ENSIGN BICKFORD DAM
CT 00567

FARMINGTON RIVER BASIN
SIMSBURY, CONNECTICUT

PHASE I INSPECTION REPORT
NATIONAL DAM INSPECTION PROGRAM

January 2, 1981

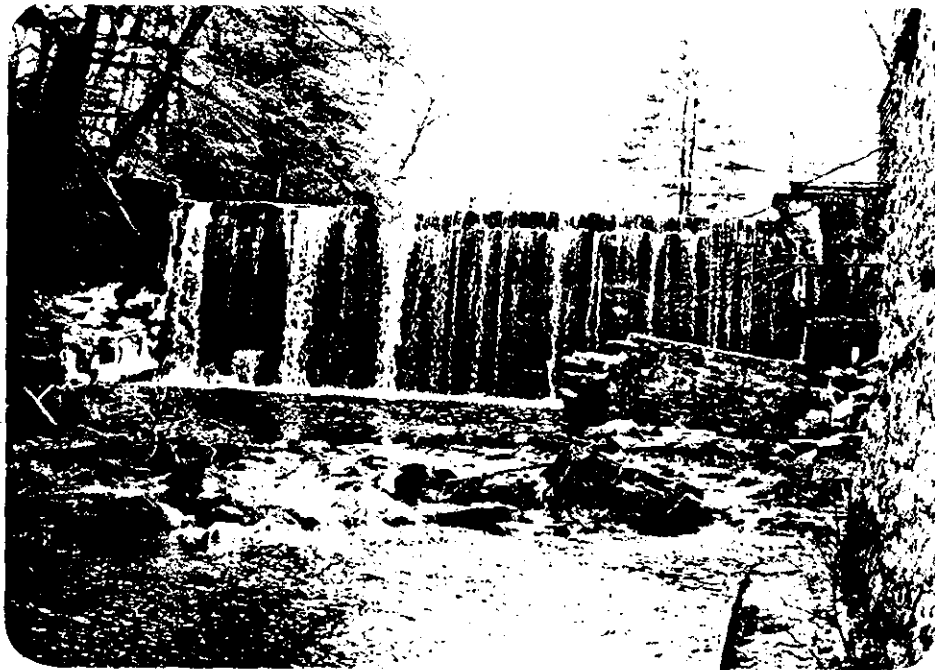
PHOTO NO. 1

The Ensign Bickford Dam consists of a dry stone masonry wall with a maximum height of about 21 feet and an upstream earth embankment. The dam is about 60 feet long, including a 35 foot overflow spillway section in the center of the dam, Photo 1. The spillway has a concrete cap extending back about 10 feet from the crest. The right abutment is a ledge outcrop, Photo 3. An old mill building is located at the left abutment, Photo 5.

SPILLWAY

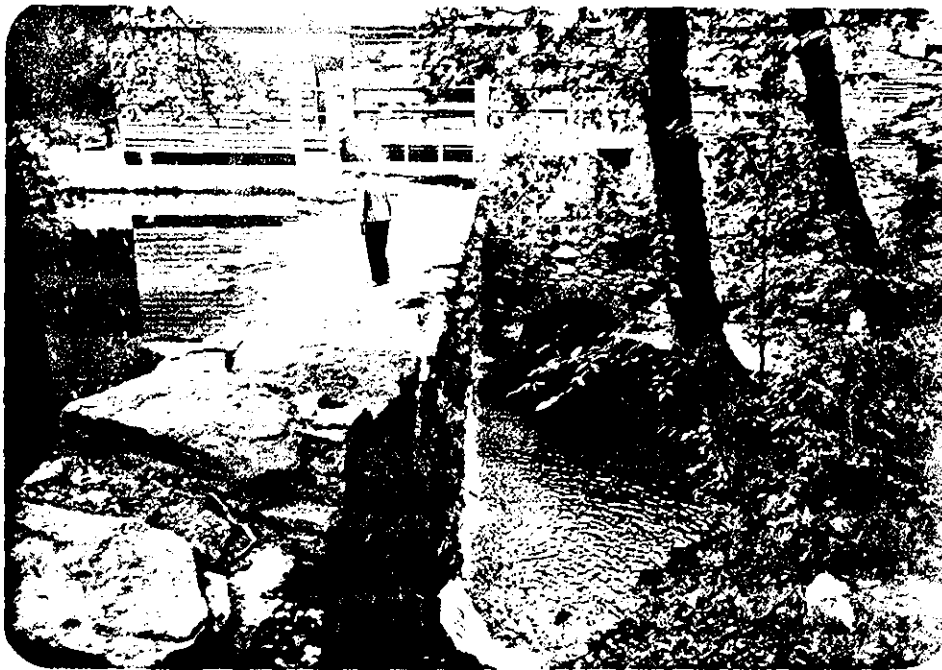
PHOTO NO. 5*

MILL BUILDING AT LEFT ABUTMENT. NOTE AUXILIARY
SPILLWAY UPSTREAM OF DAM AND DETERIORATED
CONCRETE CAP ON MAIN SPILLWAY

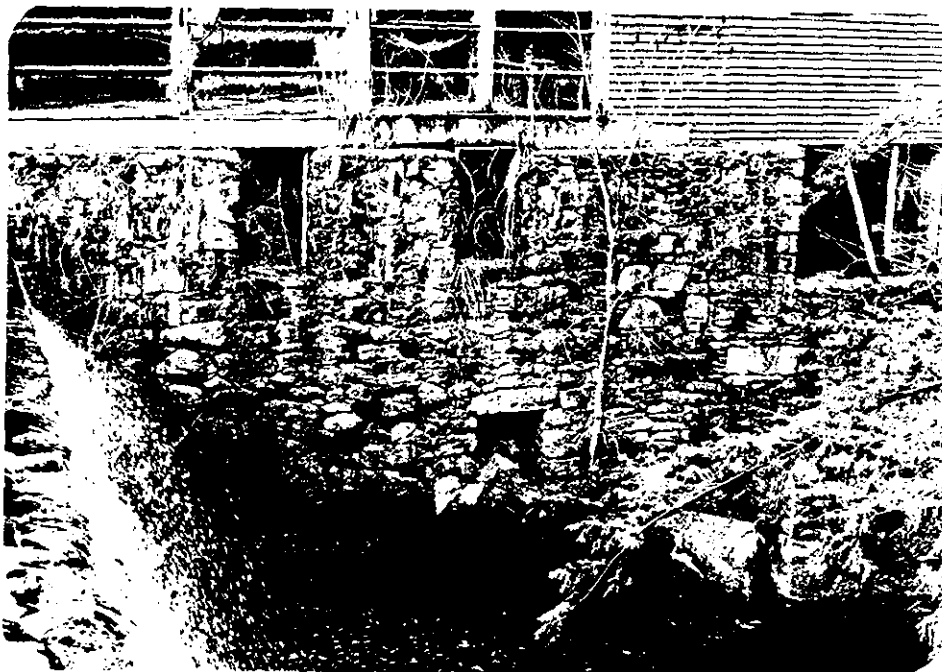
PHOTO NO. 6

FOUNDATION OF OLD MILL DOWNSTREAM OF DAM.
ARCHED CONDUIT DISCHARGES FLOW FROM NEW SLUICE GATE
AND AUXILIARY SPILLWAY

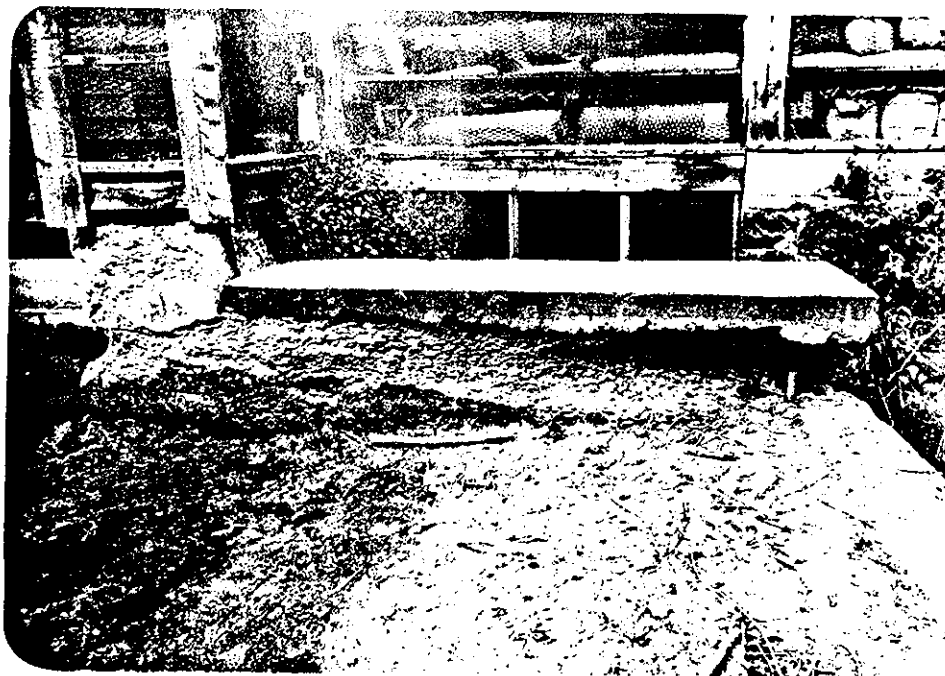
PHOTO NO. 7*

DETERIORATION OF
CONCRETE AT LEFT
SPILLWAY
TRAINING WALL

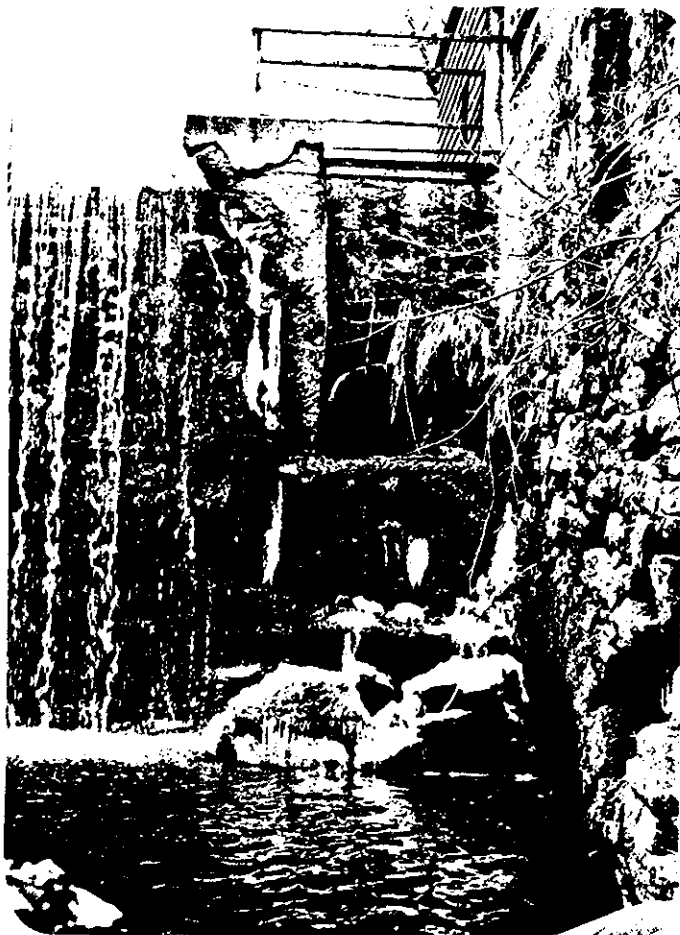
PHOTO NO. 8

DETERIORATED TRAINING WALL
AND 30-INCH OUTLET AT
LEFT END OF SPILLWAY

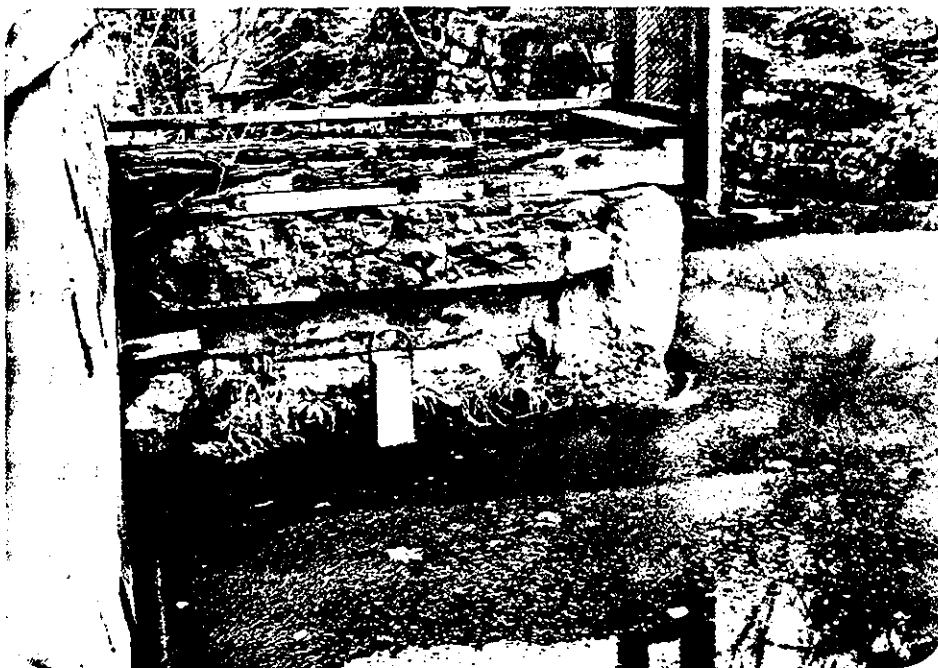
PHOTO NO. 9
OPERATOR FOR 36-INCH
OUTLET AT LEFT
SPILLWAY TRAINING
WALL

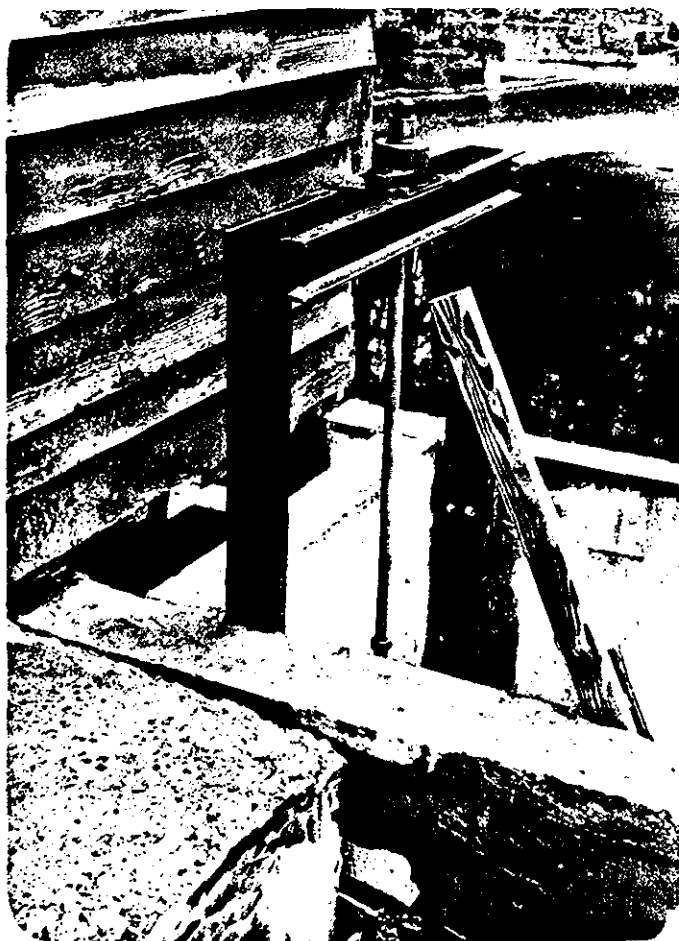
PHOTO NO. 10
NEW 4'X4' SLUICE GATE AND
CONCRETE SLUICEWAY AT LEFT
END OF DAM

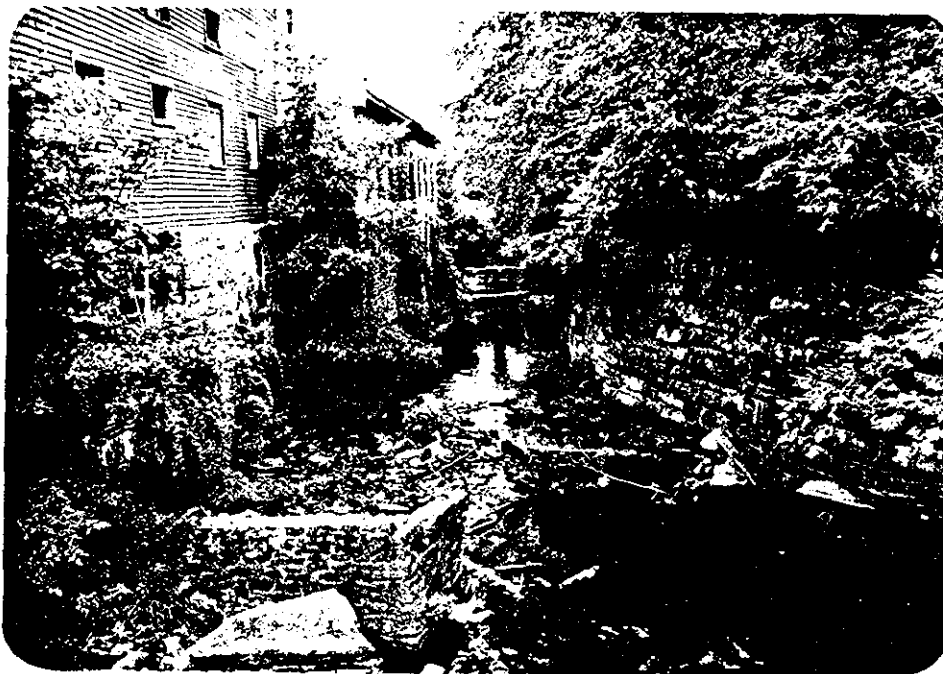
PHOTO NO. 12*

RIVER CHANNEL DOWNSTREAM OF DAM. NOTE OLD
RAILROAD RETAINING WALL AT RIGHT AND TRESTLE
PIER AT CENTER REAR
